# Manhole Inspection Summary

Manhole # S13MM\_033MH

Insp Date: **8/31/07 11:45 AM**

**Location** Address: **2901 ELGIN AVE**

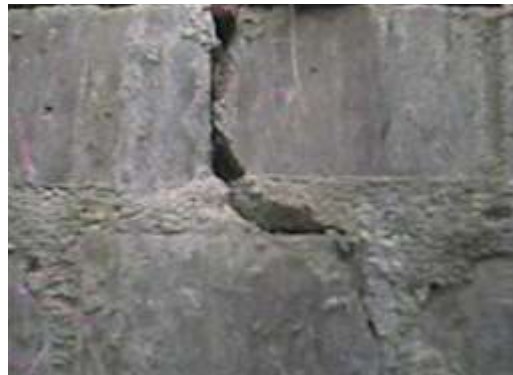
Defect 2

**Corbel** Material: **Brick** ☐ Parged Type: **Concentric/Eccentric**

Condition: ☐ Sound ☒ **Cracked** ☐ Root Intrusion ☐ Loose Brick ☐ Deteriorated

CRACKED CORBEL

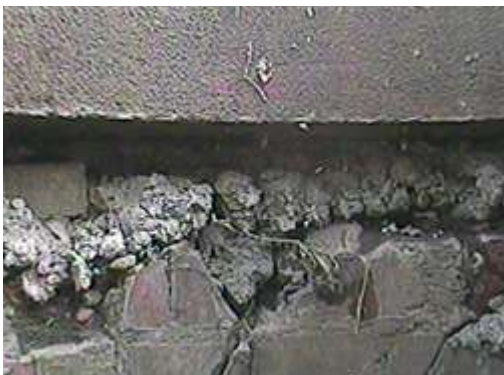
Defect 1

**Chimney / Frame Adjustment** ☒ Exists Material: **Brick and Concrete** ☐ Parged Height: **8** (in.)

Condition: ☐ Sound ☒ **Cracked** ☐ Root Intrusion ☒ **Loose Brick** ☒ **Deteriorated**

DETERIORATED / LOOSE BRICK/  
CRACKED ADJ.

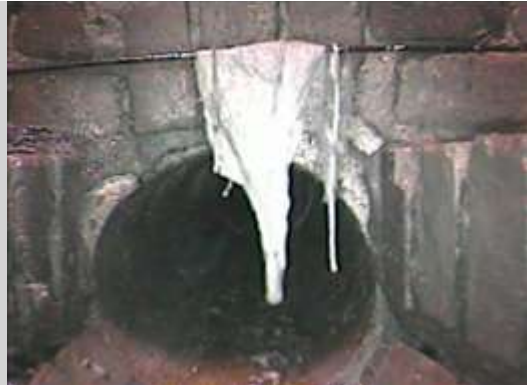
12 O'Clock Outflow

8 in. Circular Gravity Sewer  
Pipe Out @ 12 O'Clock

Pipe Height: (in.) Direct  
Pipe Material: **Clay** ☐ Pipe Lined  
Invert Depth: **8.30** (ft.) Flow Characteristics: **Fast**  
Deposits: ☒ None ☐ Mud ☐ Sludge ☐ Debris ☐ Grease  
Silt Depth: (in.) Deposits Extent:  
Infiltration: **None** Pipe Seal Cond: **Sound**

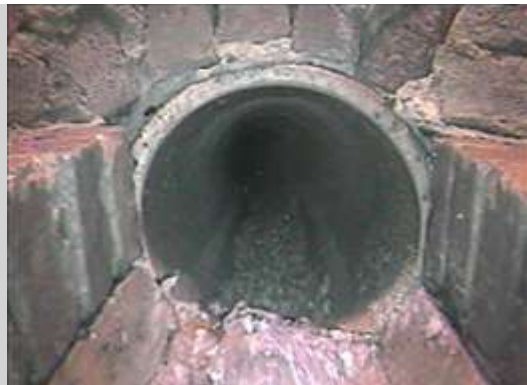
3 O'Clock Inflow

8 in. Circular Gravity Sewer  
Pipe In @ 3 O'Clock

Pipe Height: (in.) Direct  
Pipe Material: **Clay** ☐ Pipe Lined  
Invert Depth: **8.04** (ft.) Flow Characteristics: **Fast**  
Deposits: ☒ None ☐ Mud ☐ Sludge ☐ Debris ☐ Grease  
Silt Depth: (in.) Deposits Extent:  
Infiltration: **None** Pipe Seal Cond: **Sound**
